Report of the inquest  
into the deaths arising from the  
Thredbo landslide

**Derrick Hand**  
**Coroner**  
**29 June 2000**

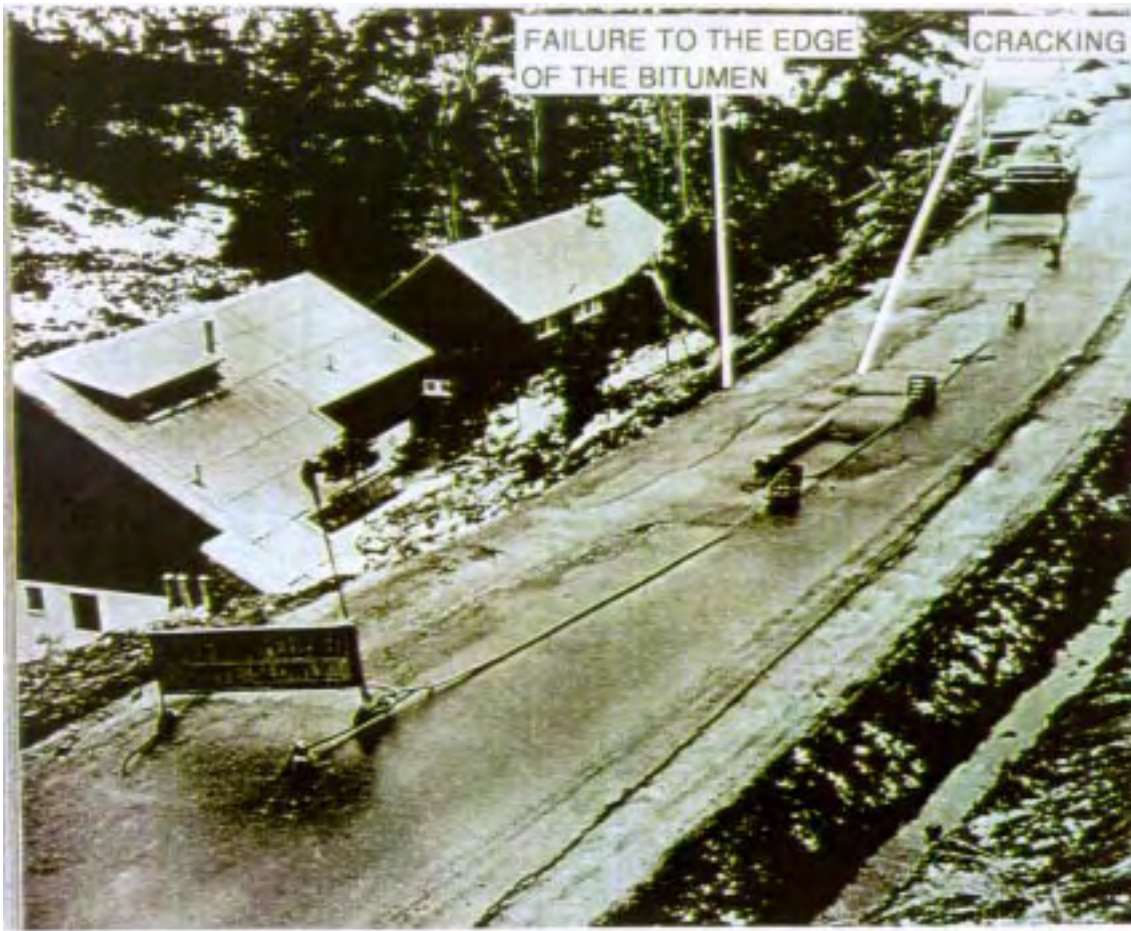
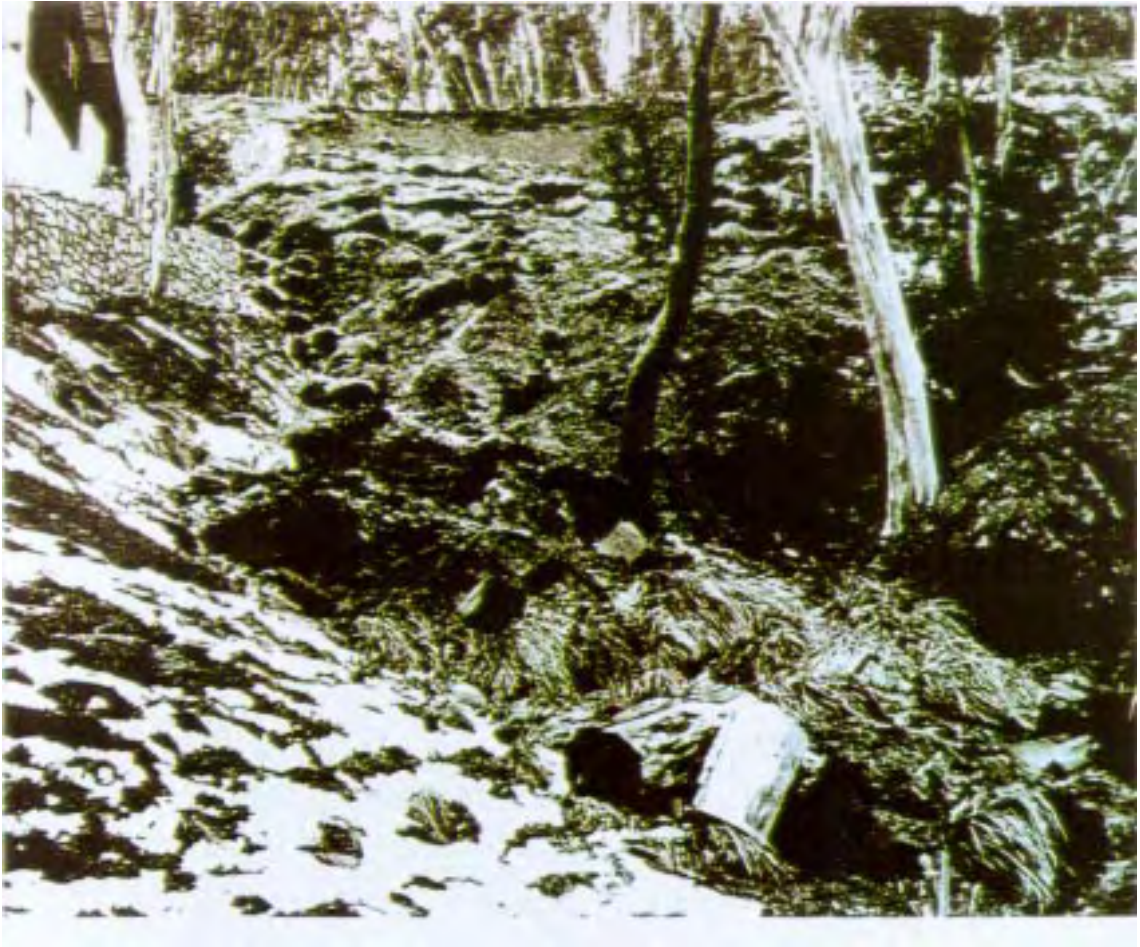
Figure 4. Photograph of the 1964 landslide

116. The Winterhaus landslide occurred on 2 October 1964. It involved the sudden slump of an outer segment of the fill on the Alpine Way above the Winterhaus Lodge through a vertical distance of about 6 feet. That slump was followed by a further vertical displacement to about 9 feet below the road pavement which occurred slowly over the following three days accompanied by a mudflow down-slope extension at the toe of the landslide. Prior to the landslide occurring, cracks and differential settlement of the pavement of the Alpine Way had developed. They were accompanied by several small isolated water outflows from the fill down-slope of the road (see Appendix 10, Figures 4 and 5).
